Repair sheet

Replacing seal (108414PA002) and oil-retaining ring (108414BP005)

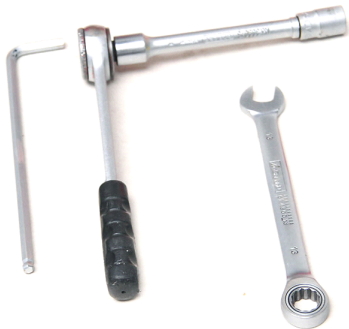
Step 1

Required tools, part 1.

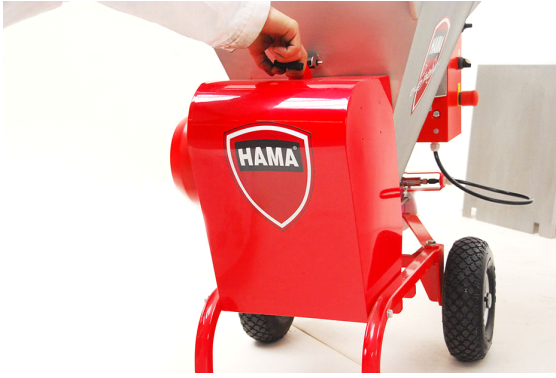
Step 2

Open the motor cover on the machine.

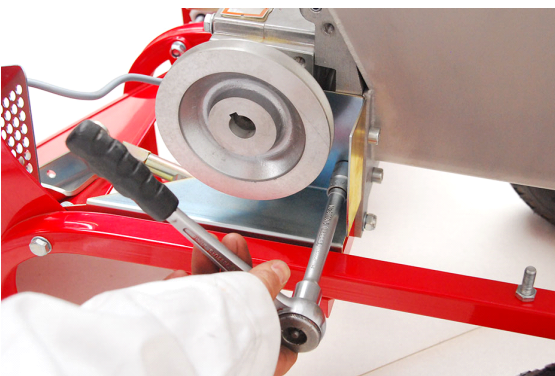
Step 7

Also loosen the bolt for the bottom guard.

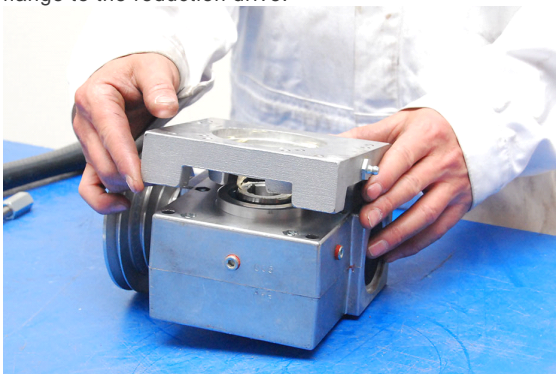
Now remove the intermediate flange.

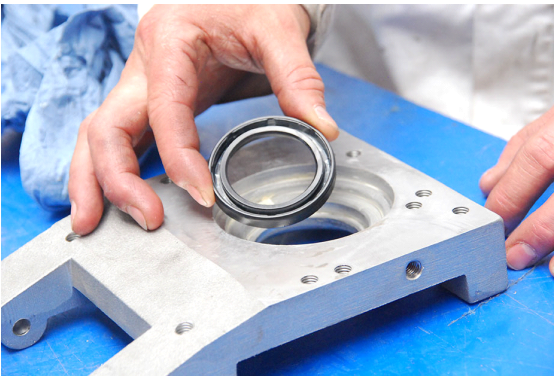
Step 15

Fit the new oil-retaining ring (108414BP005) in the intermediate flange in the proper manner.

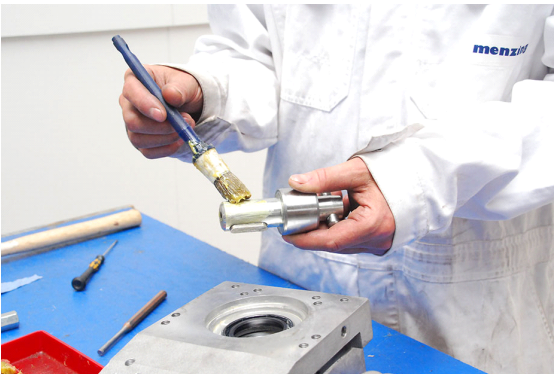
Step 17

Grease the spindle MC3V (108402AS007).

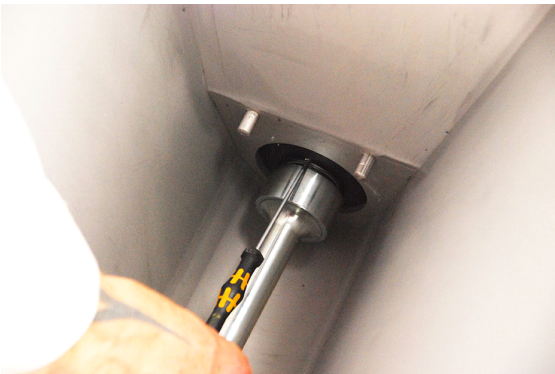
Step 19

Greasing the seal. Position a small screwdriver between the seal (108414PA002) and the stainless steel hopper. Fit the grease pump to the grease nipple and pump several strokes.

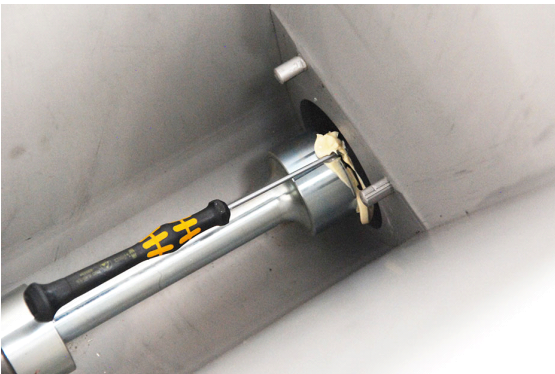
Step 20

When grease appears at the seal (108414PA002) on the inside of the stainless steel hopper you have applied enough grease. Please note that this procedure must be repeated annually.

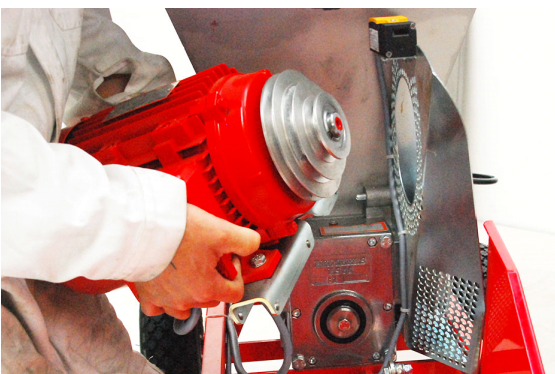
Step 21

Now fit the motor and motor base plate back on the machine.

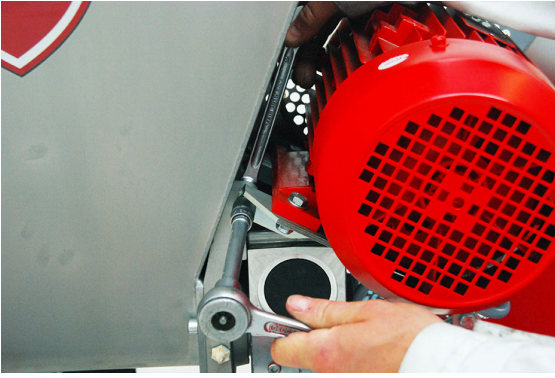
Tighten the mounting bolt with washer that secures the motor base plate.

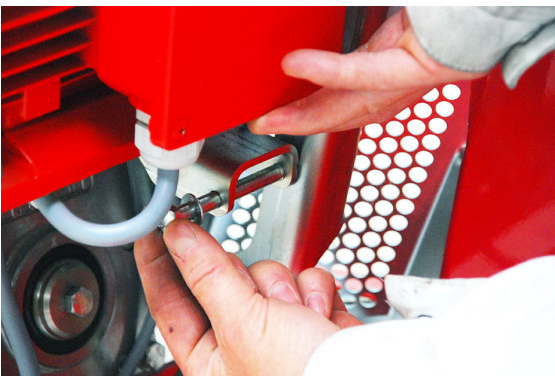
Step 23

Fit the bolt with washer back in the handle of the V-belt tensioner and the motor base plate. Do not overtighten the bolt, because the handle must be free to turn.

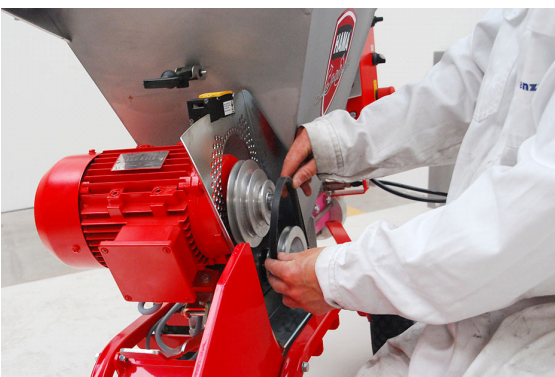
Step 24

Now fit the V-belt (108414BP002) back on the pulleys.

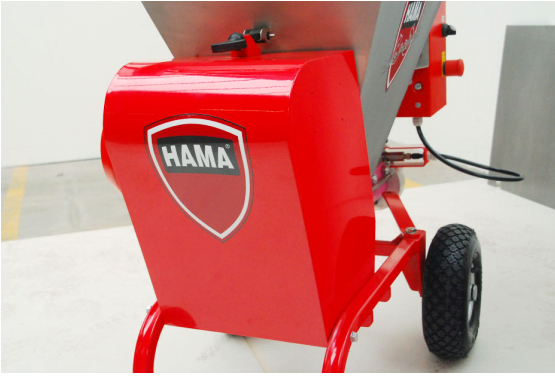
Step 24

Ensure that all the bolts and nuts have been tightened firmly. The machine is now ready for use again.
